MTL TR 91-24

# EXAMINATION OF PROTECTIVE COATINGS UTILIZED ON ARMY DS2 CONTAINERS

VICTOR K. CHAMPAGNE, Jr., MARC S. PEPI,  
CATHERINE M. ZOLLER, and SAUL ISSEROW  
MATERIALS TESTING AND EVALUATION BRANCH

June 1991

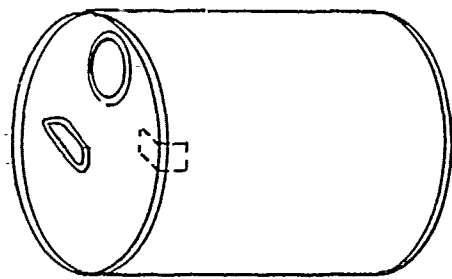
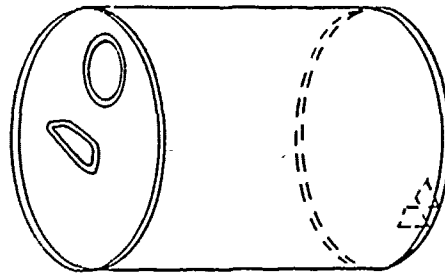
Figures 17 and 18 are schematics which identify the areas where cross-sectional specimens were taken from the five-gallon container. The corresponding surfaces which were prepared for metallographic examination are also indicated. Table 2 lists the specimens that were sectioned from the container.

Figure 17. Metallographic cross sections of five-gallon container.

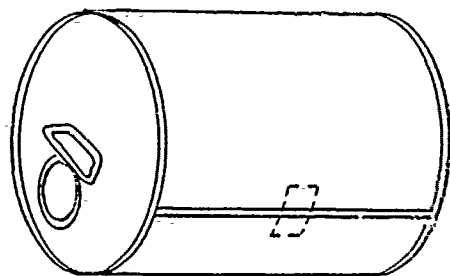
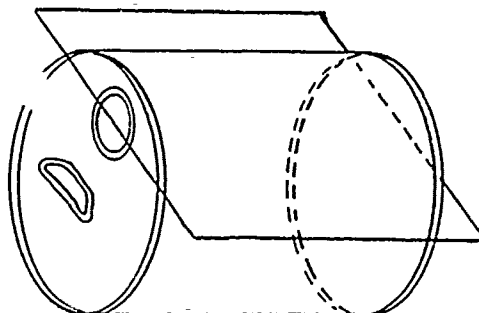
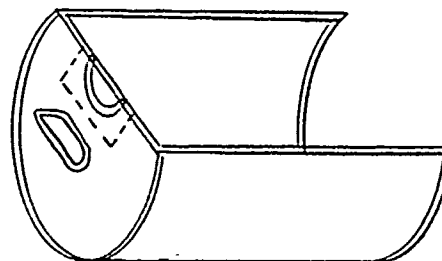
Figure 18. Metallographic cross sections of five-gallon container.

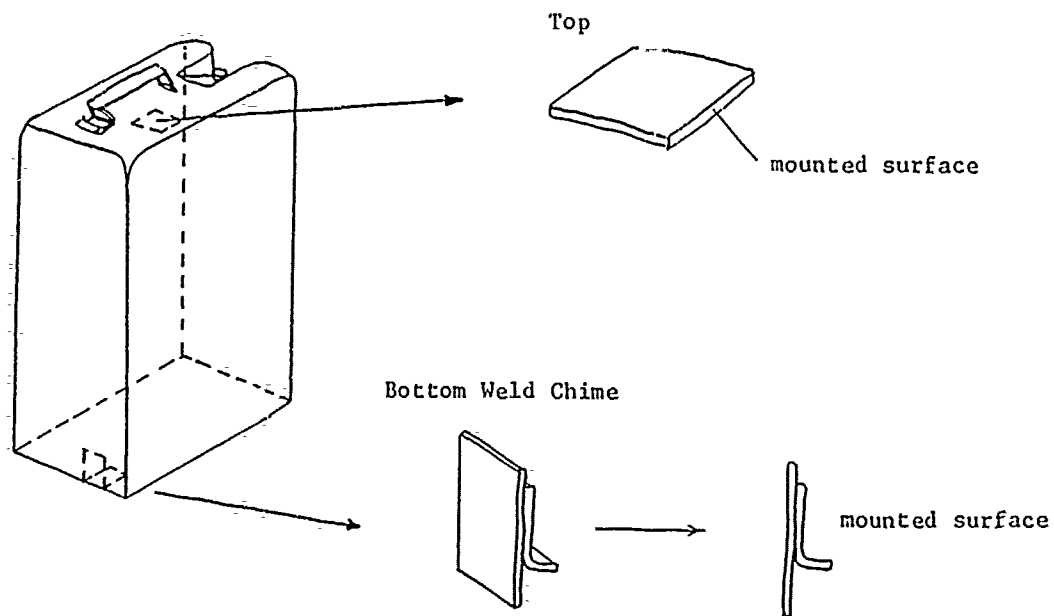
Figures 23 and 24 are schematics which identify the areas where cross-sectional specimens were taken from the 14-liter container. The corresponding surfaces which were prepared for metallographic examination are also indicated. Table 4 lists the specimens that were sectioned from the container.

Figure 23. Metallographic cross sections of 14-liter container.

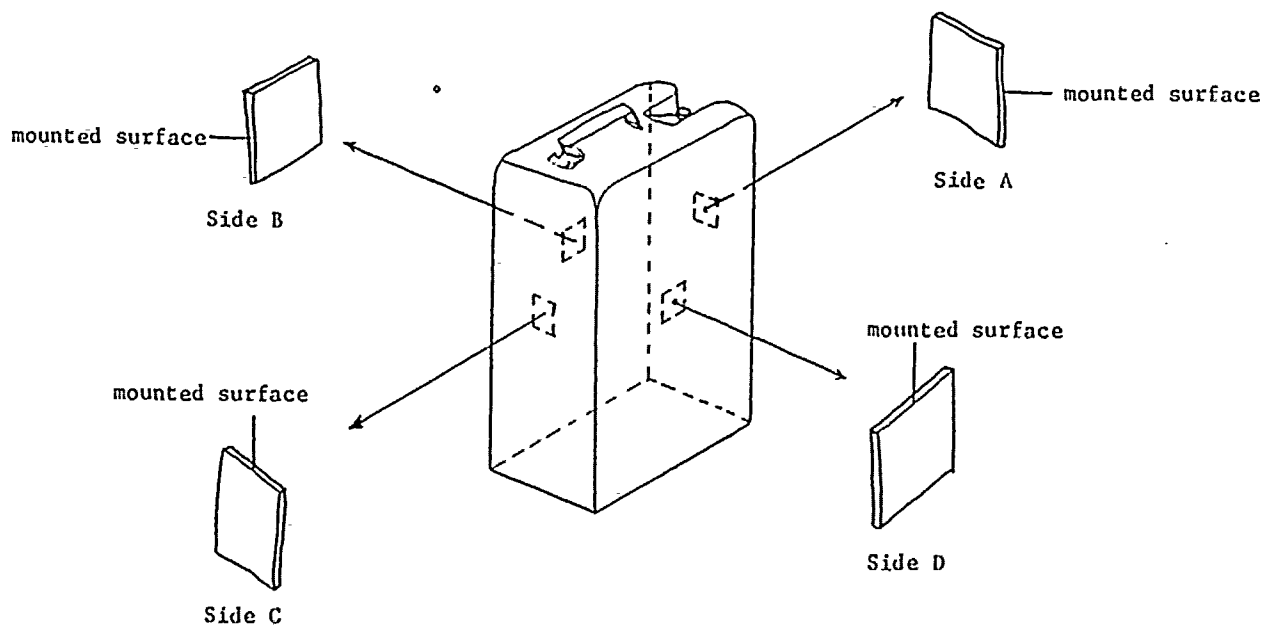
Figure 24. Metallographic cross sections of 14-liter container.

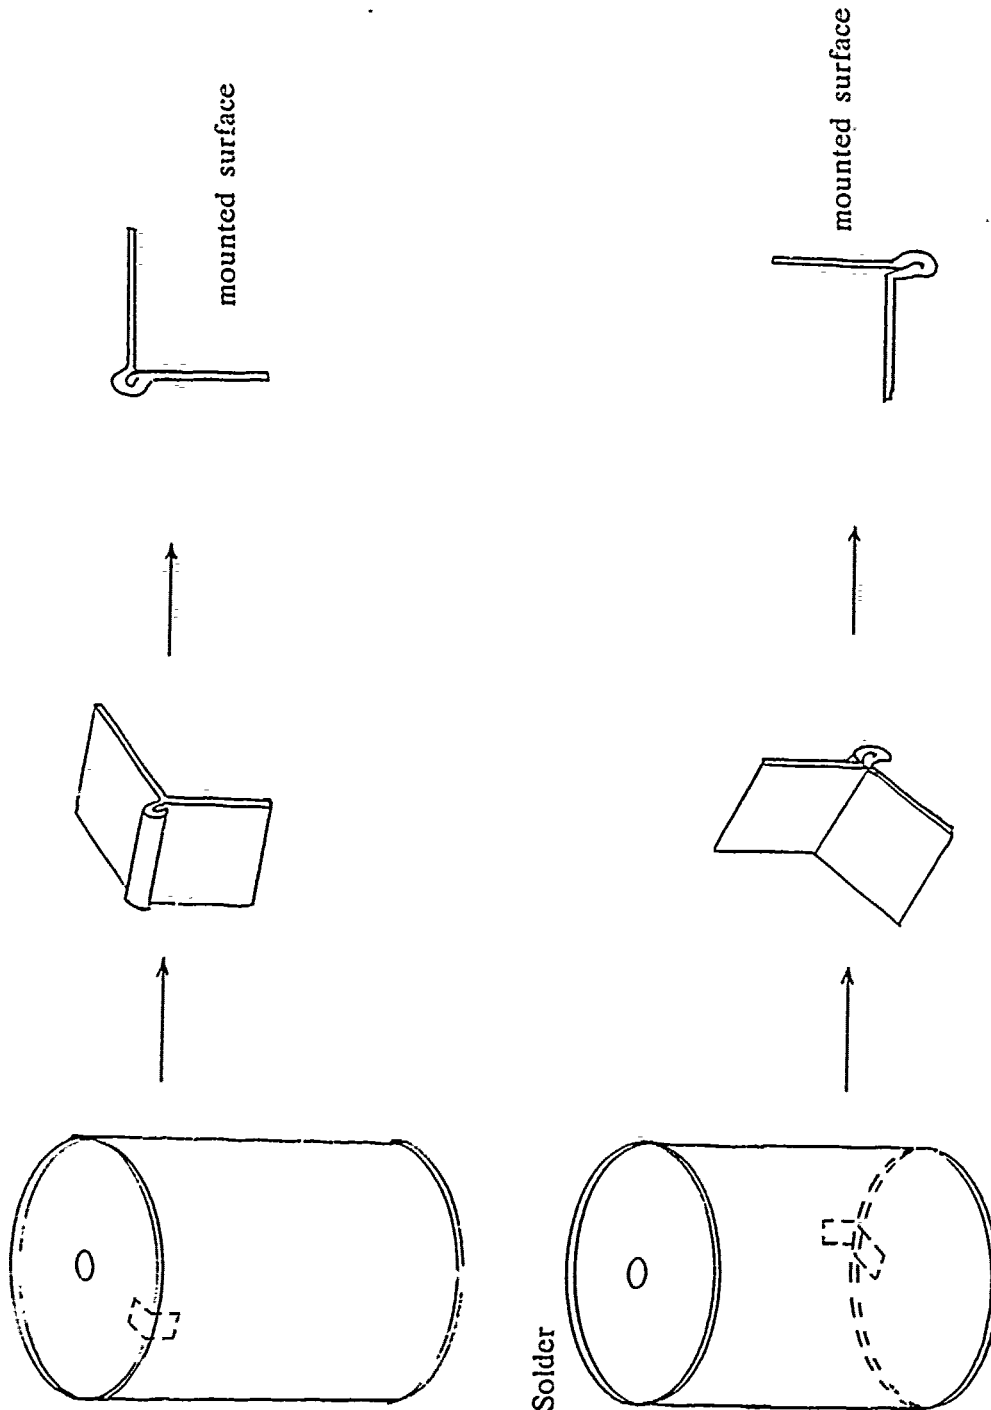
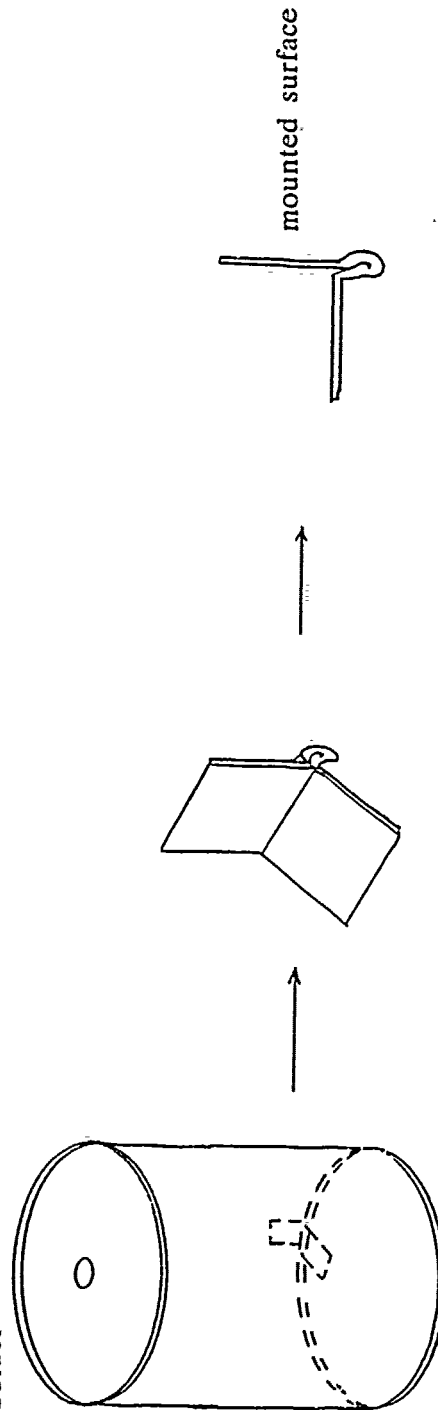
Figures 27 and 28 are schematics which identify the areas where cross-sectional specimens were taken from the 1-1/3-quart container. The corresponding surfaces which were prepared for metallographic examination are also indicated. Table 6 lists the specimens that were sectioned from the container.

Figure 27. Metallographic cross sections of 1-1/3-quart container.

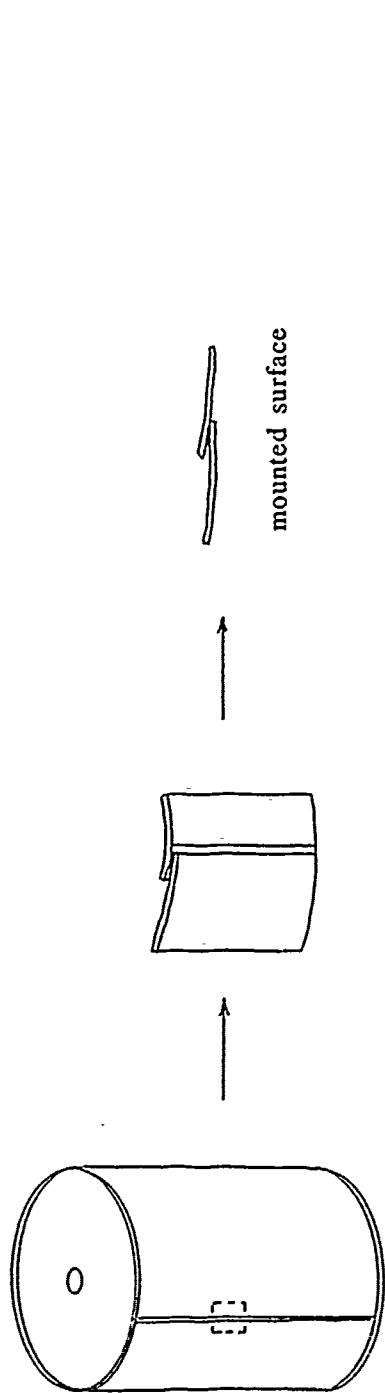
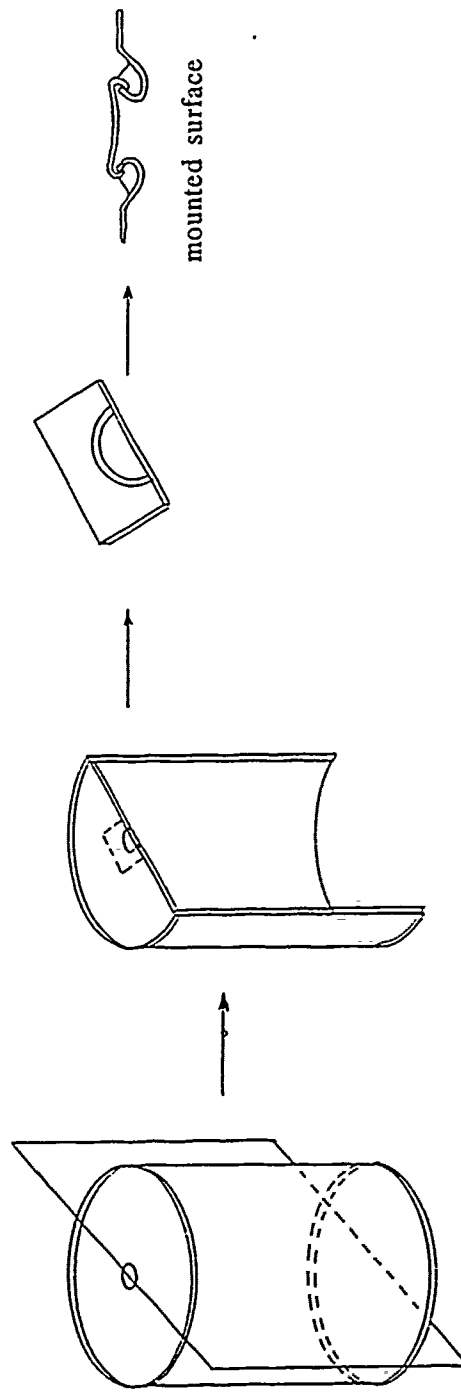
Figure 28. Metallographic cross sections of 1-1/3-quart container.

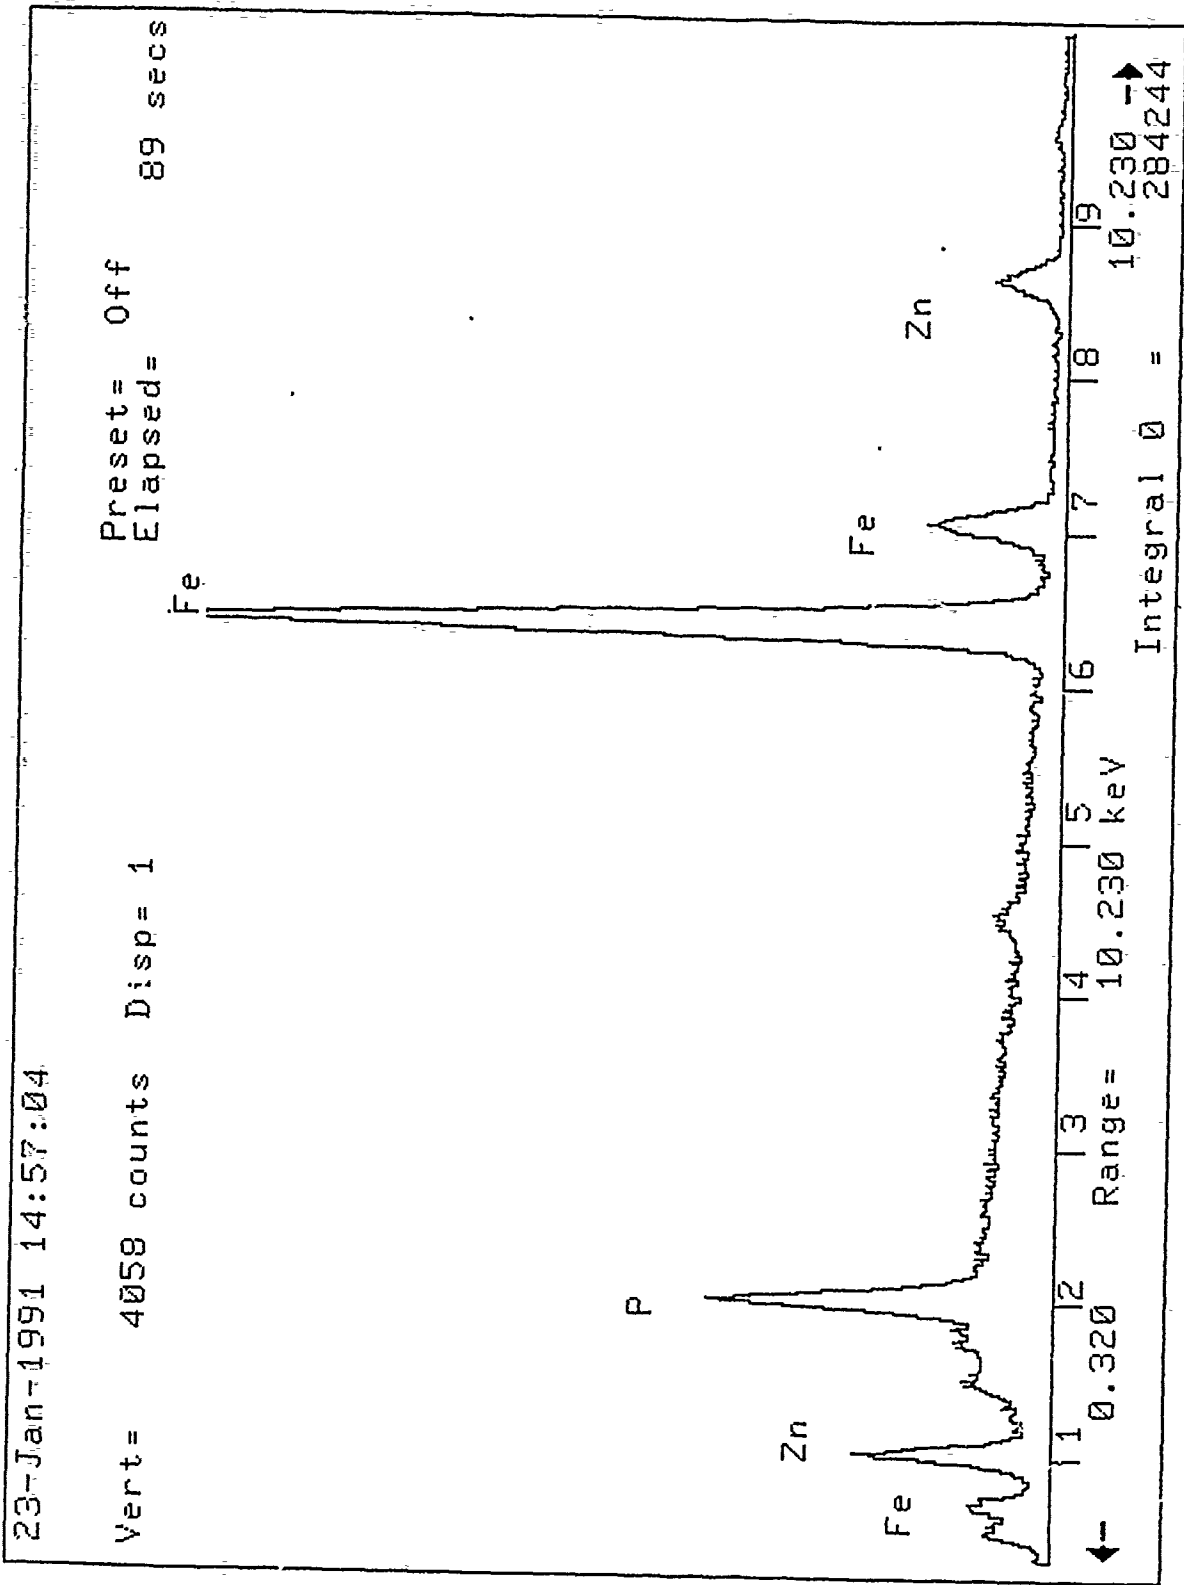
Figure 35. Energy Dispersive Spectroscopy of the exterior base metal of the five-gallon container.  
The zinc and phosphorous detected indicate the presence of a zinc phosphate pretreatment.

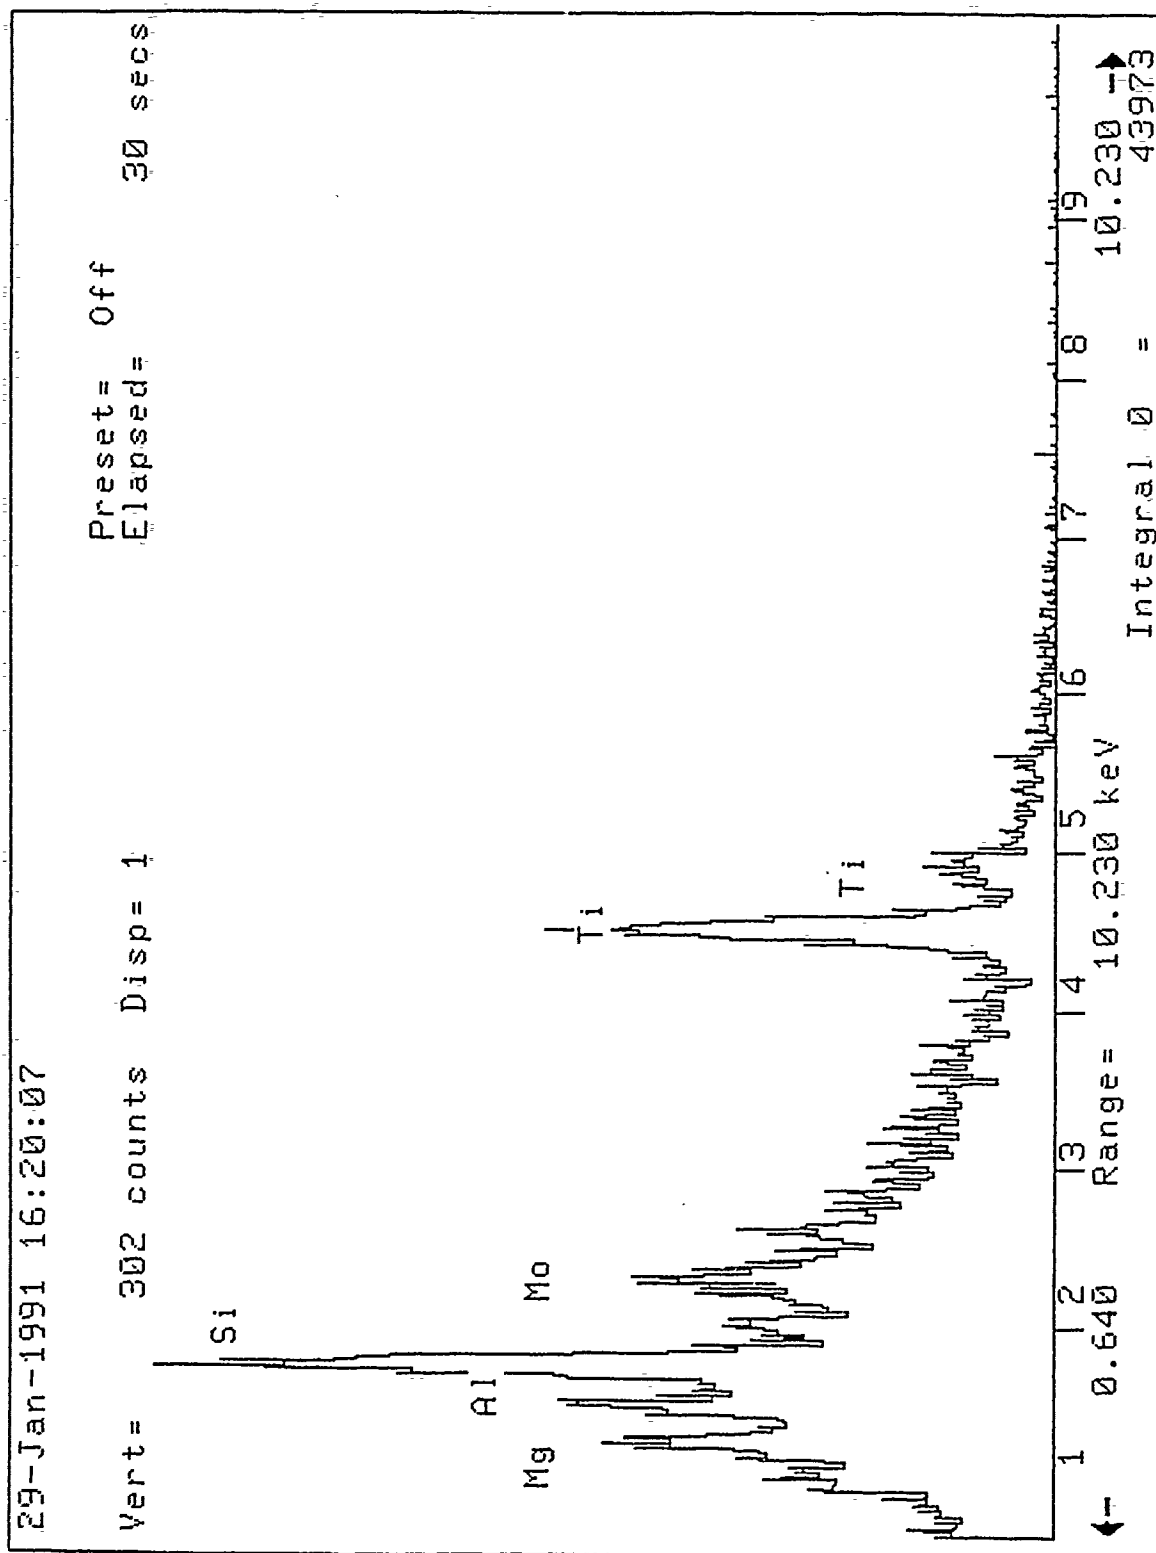
Figure 36. Energy dispersive spectroscopy of the epoxy primer of the five-gallon container. Silicon, titanium, aluminum, magnesium, and molybdenum are constituents of pigments added to the epoxy primer.

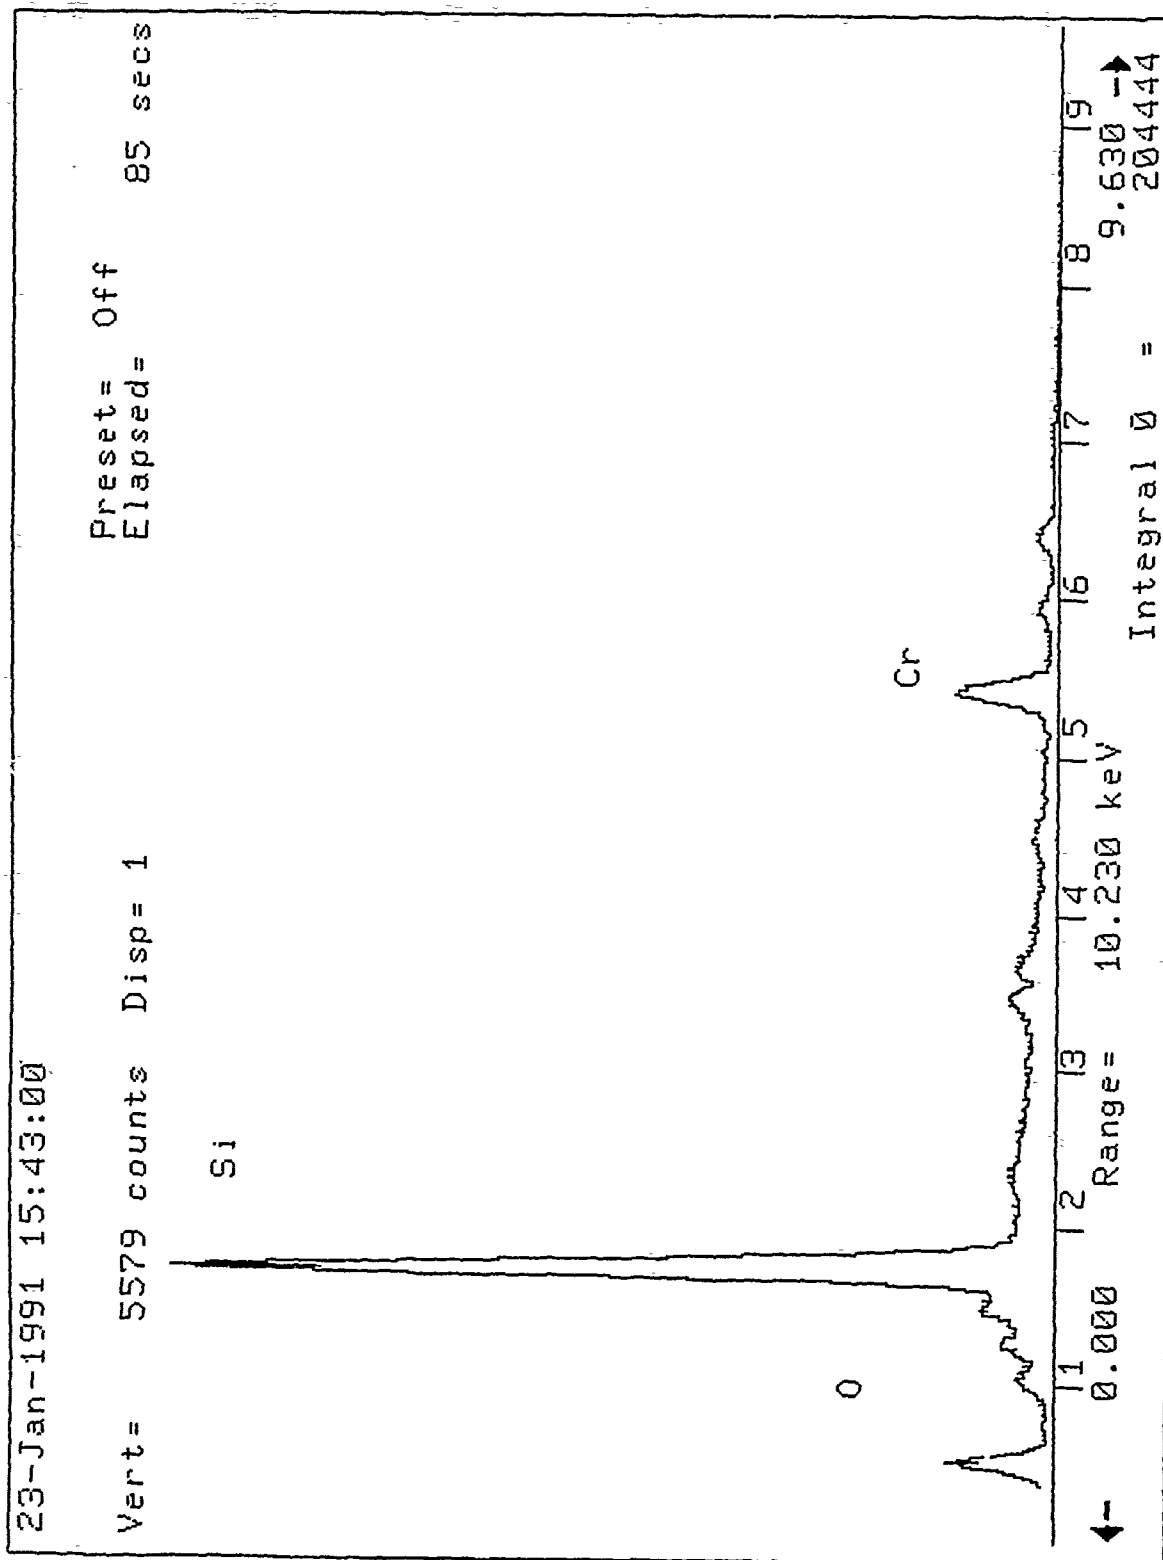
Figure 37. Energy dispersive spectroscopy of the topcoat of the five-gallon container. Silicon, chromium, and oxygen were detected. Each are constituents of pigments added to the topcoat.

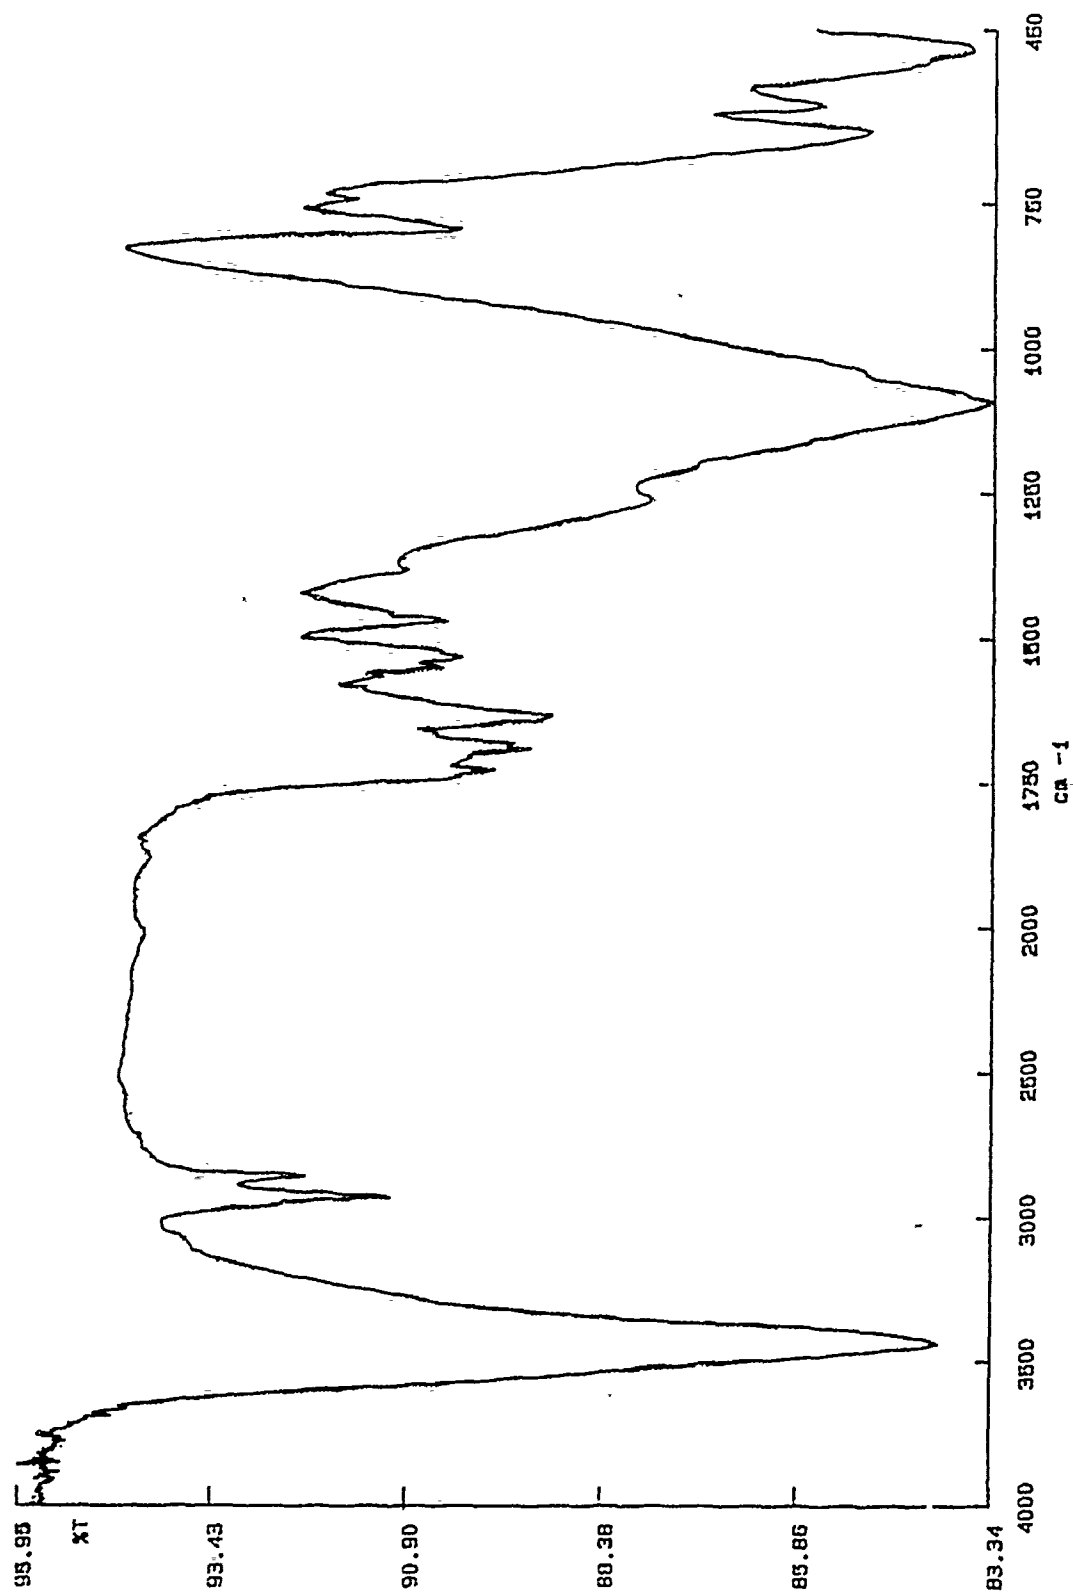
Figure 38. Infrared spectra collected from topcoat of five-gallon container indicative of urethane.

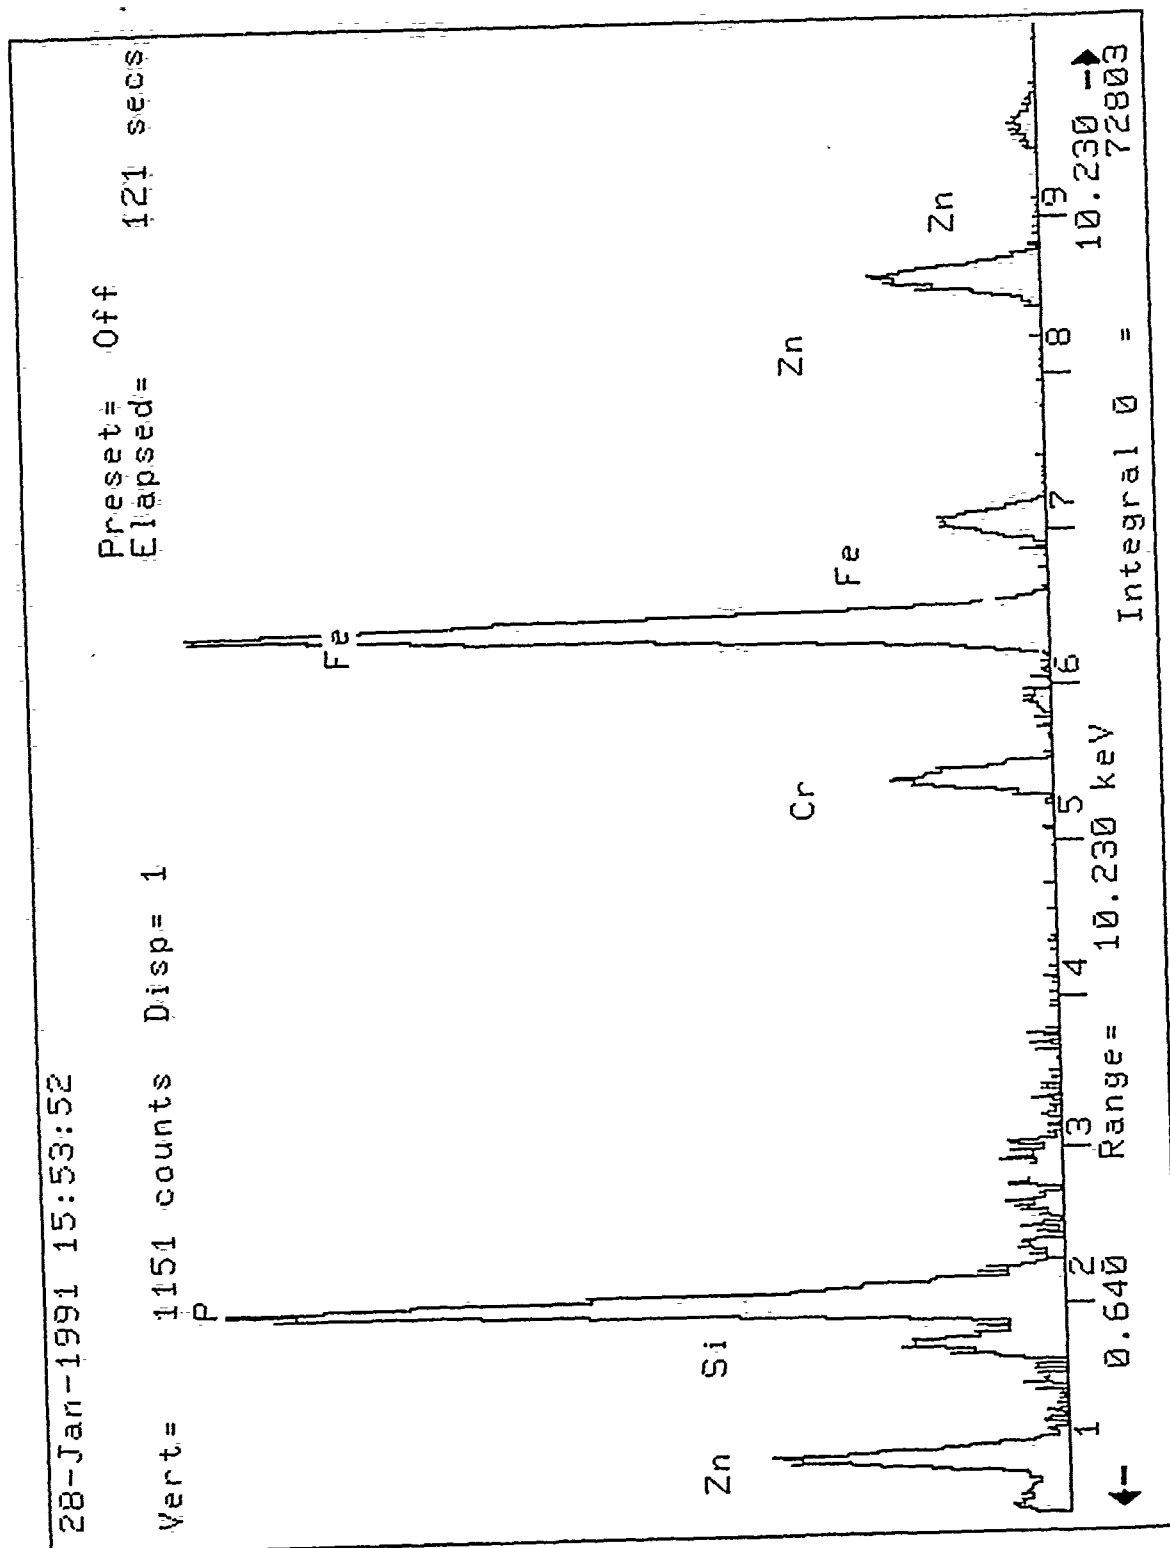
Figure 39 shows an SEM micrograph of the coatings located on Side C of the 14-liter container. The photograph identifies the various layers. Figure 40 is the EDS spectrum of the wash primer showing high peaks of phosphorus, zinc, and chromium, as well as iron which represents the steel substrate. Figures 41 and 42 contain the spectrum of the epoxy primer and topcoat, respectively. Magnesium, silicon, and iron are contained in pigments added to the epoxy primer for rust inhibitive properties and color. Figure 43 is the infrared spectrum of the topcoat which is indicative of a polyurethane.

Figure 40. Energy dispersive spectroscopy of the base coating upon the exterior surface of the 14-liter container. The zinc, chromium, and phosphorous indicate the presence of a wash primer. The silicon is most likely evidence of the epoxy primer and the iron indicative of the underlying metal substrate.

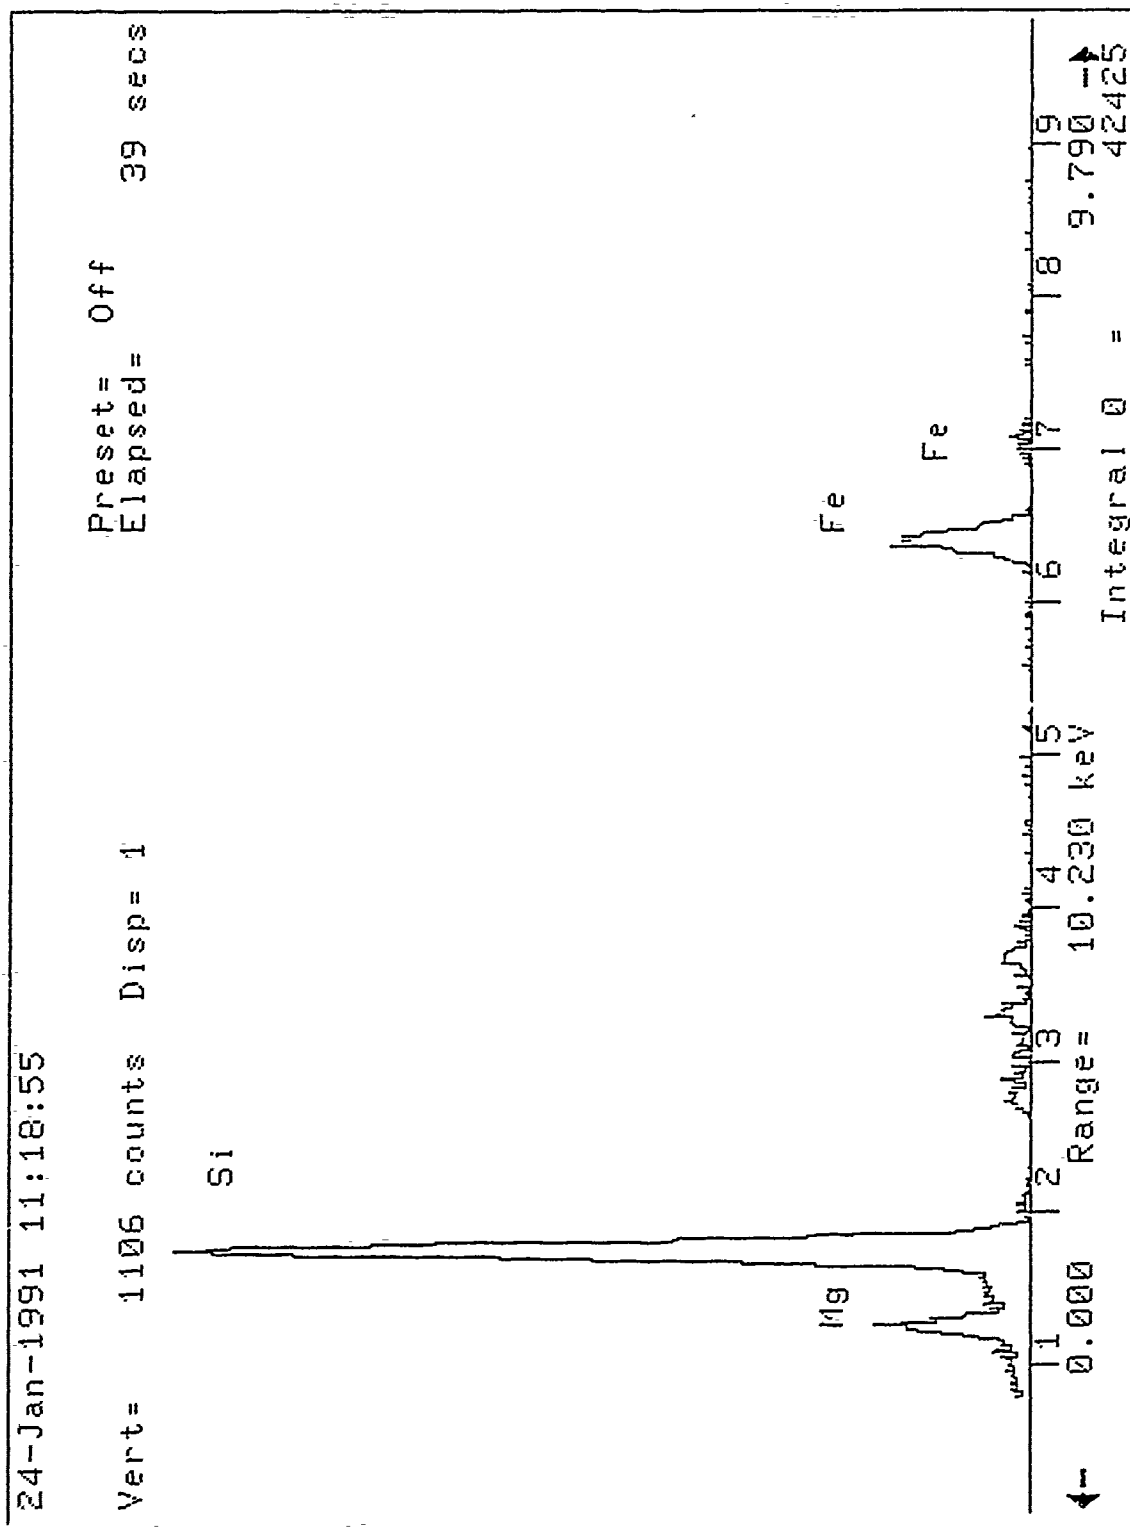
Figure 41. Energy dispersive spectroscopy of the epoxy primer on the exterior of the 14-liter container. Silicon, iron, and magnesium are all constituents of pigments added to the epoxy primer.

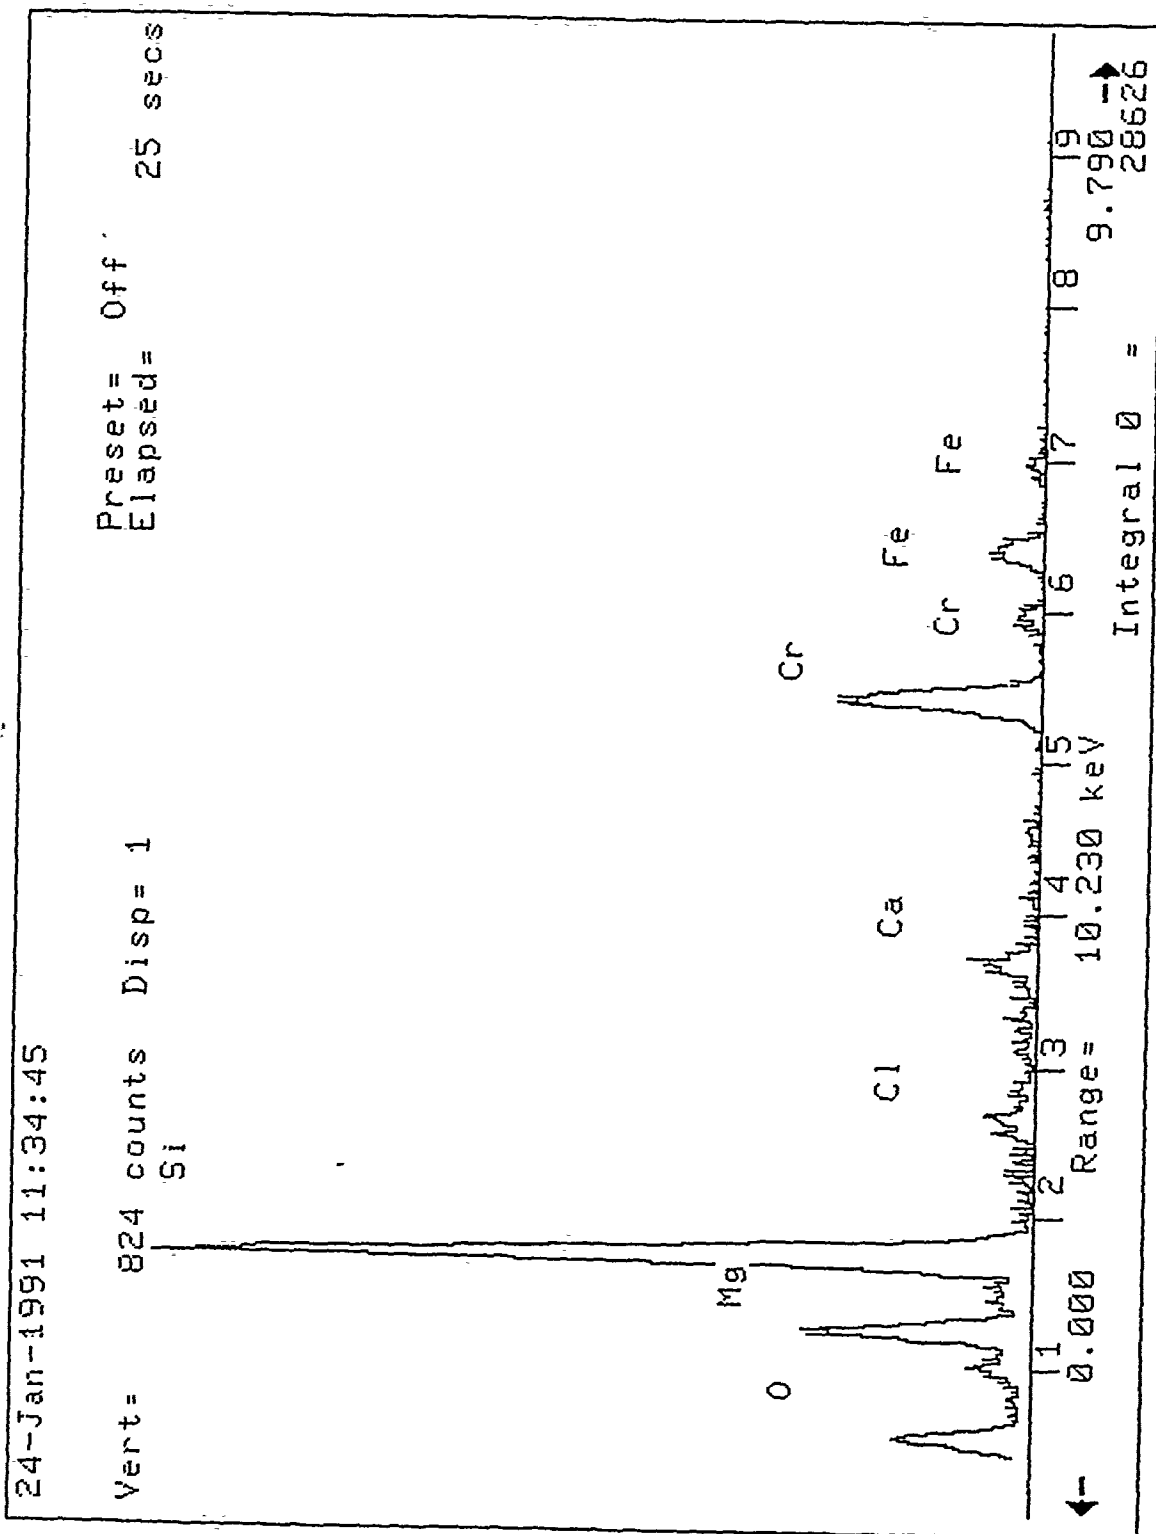
Figure 42. Energy dispersive spectroscopy of the exterior topcoat of the 14-liter container. Silicon, magnesium, oxygen, chromium, calcium, and iron are constituents of the pigments added to the topcoat. The presence of chlorine could indicate a contaminated sample surface.

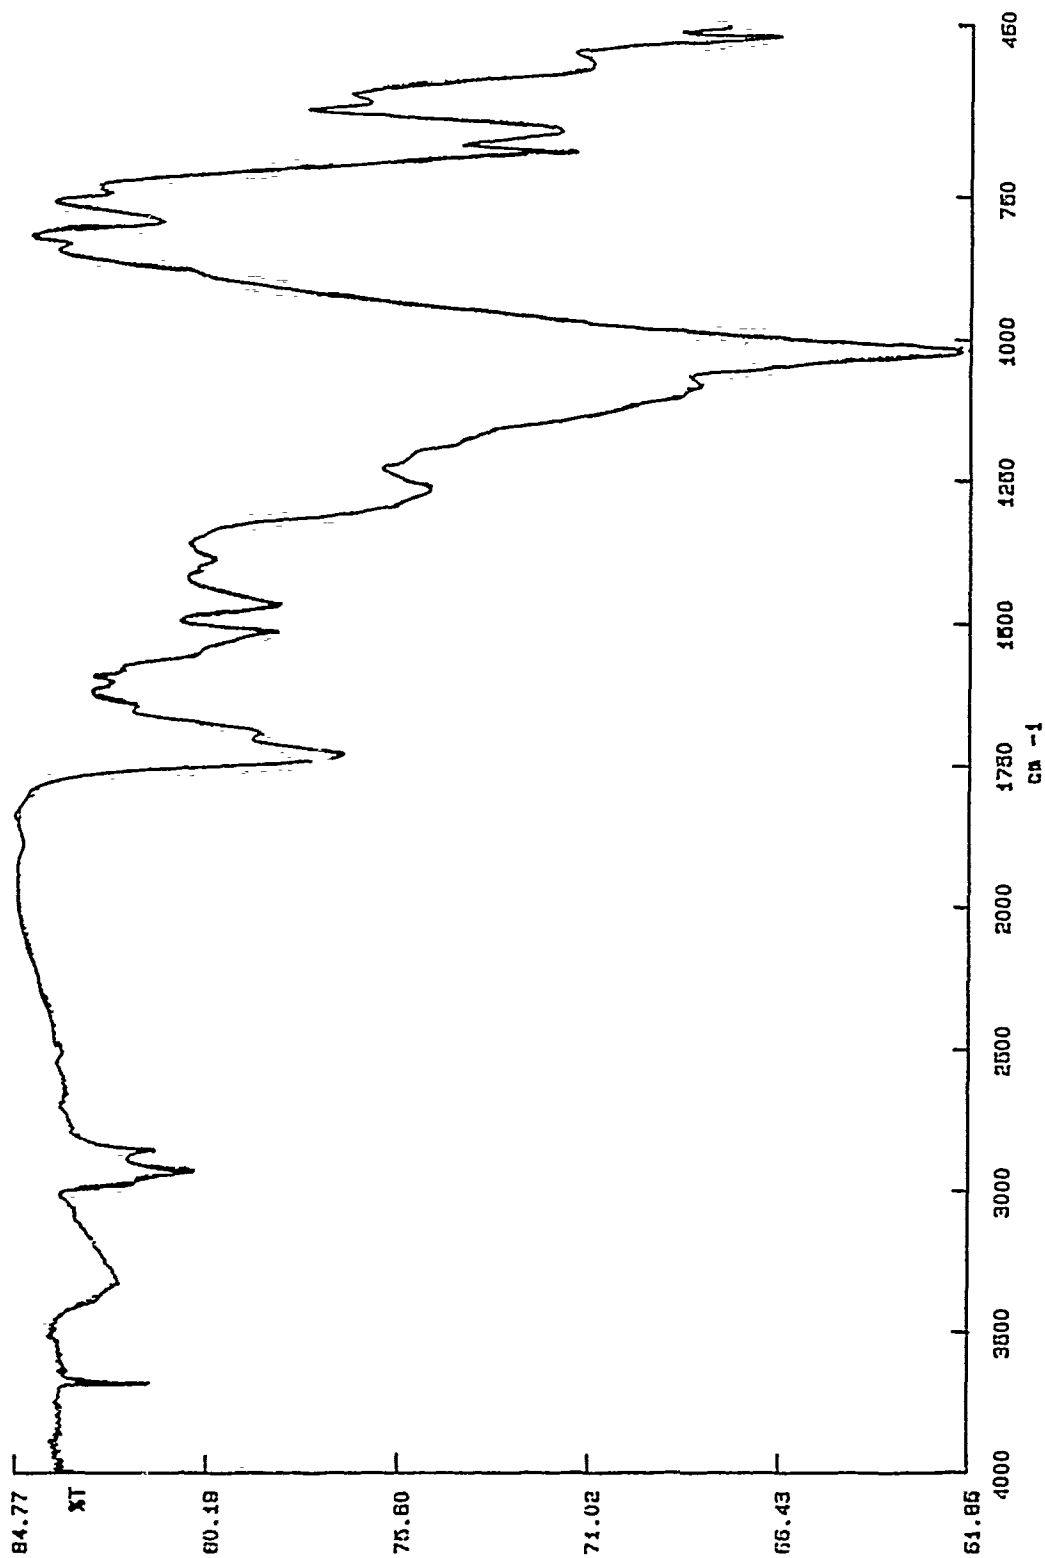
Figure 43. Infrared spectra collected from topcoat of 14-liter container indicative of polyurethane.

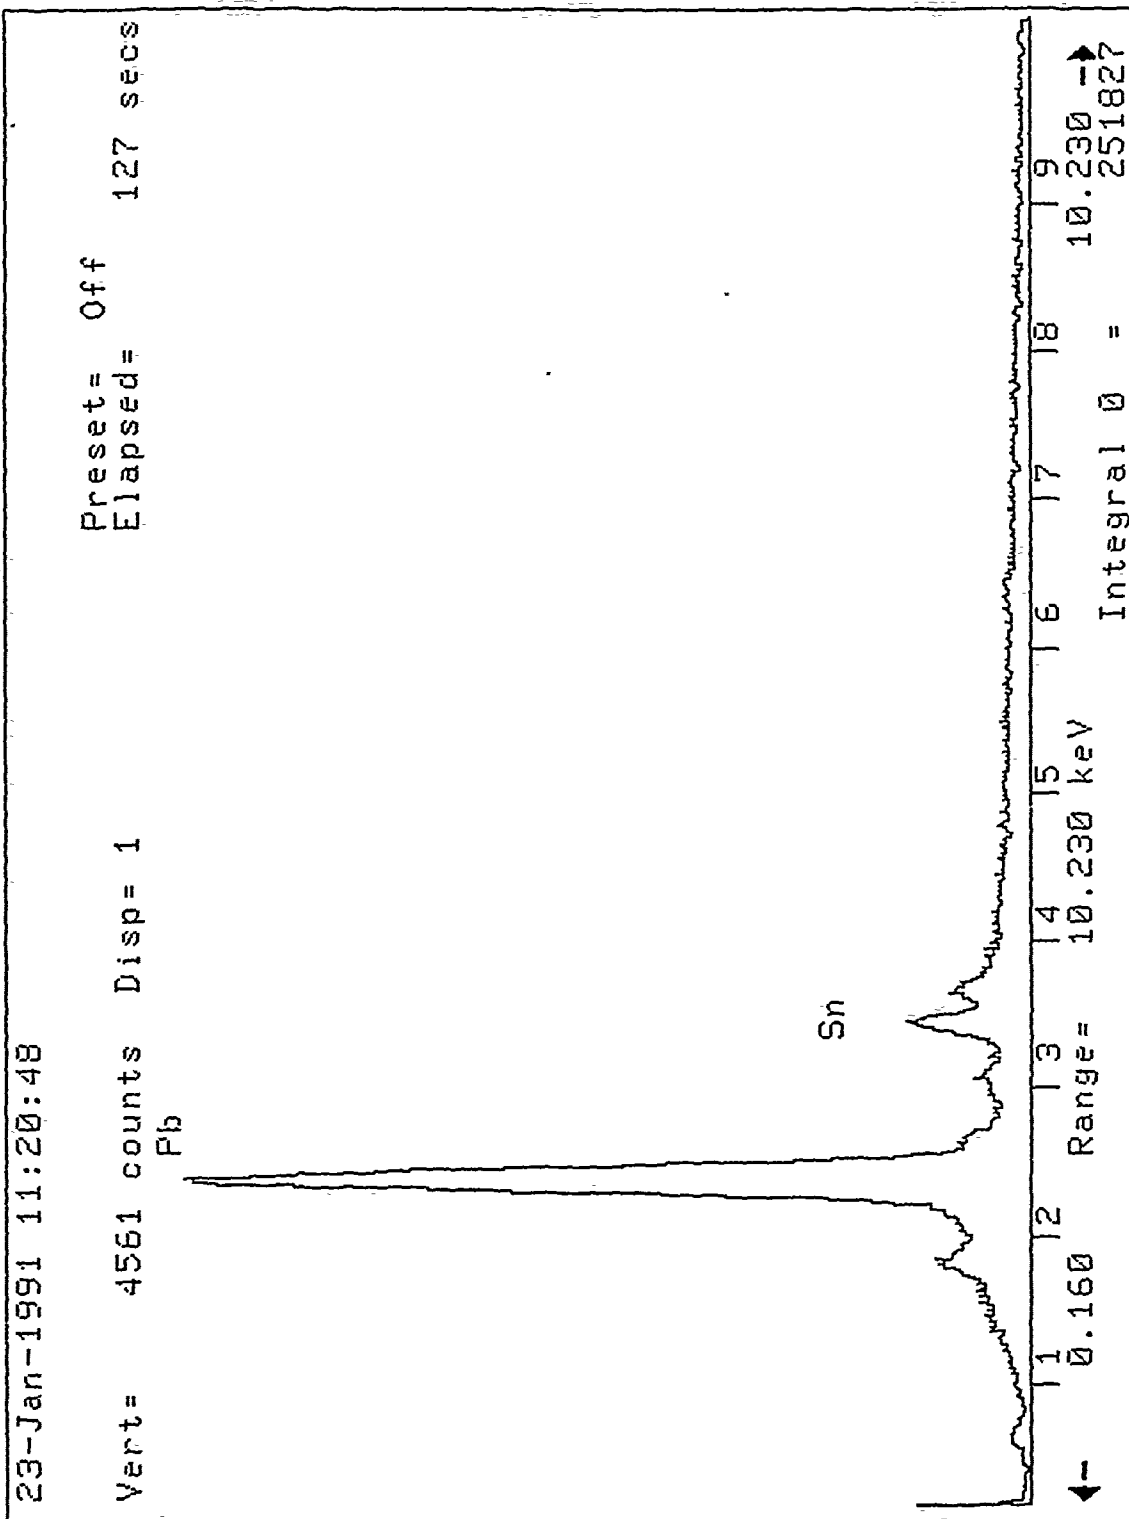
Figure 46. Energy dispersive spectroscopy of the undercoat present on the exterior of the 1-1/3-quart container. .  
The main elemental constituents of lead and tin indicate a tene coating.
